**REPAIRS TO CARTERET COMMUNITY THEATRE**  
 MOREHEAD CITY, NORTH CAROLINA

REPAIR FLOOR PLAN

SHEET NO.  
**BD-3**  
 OF

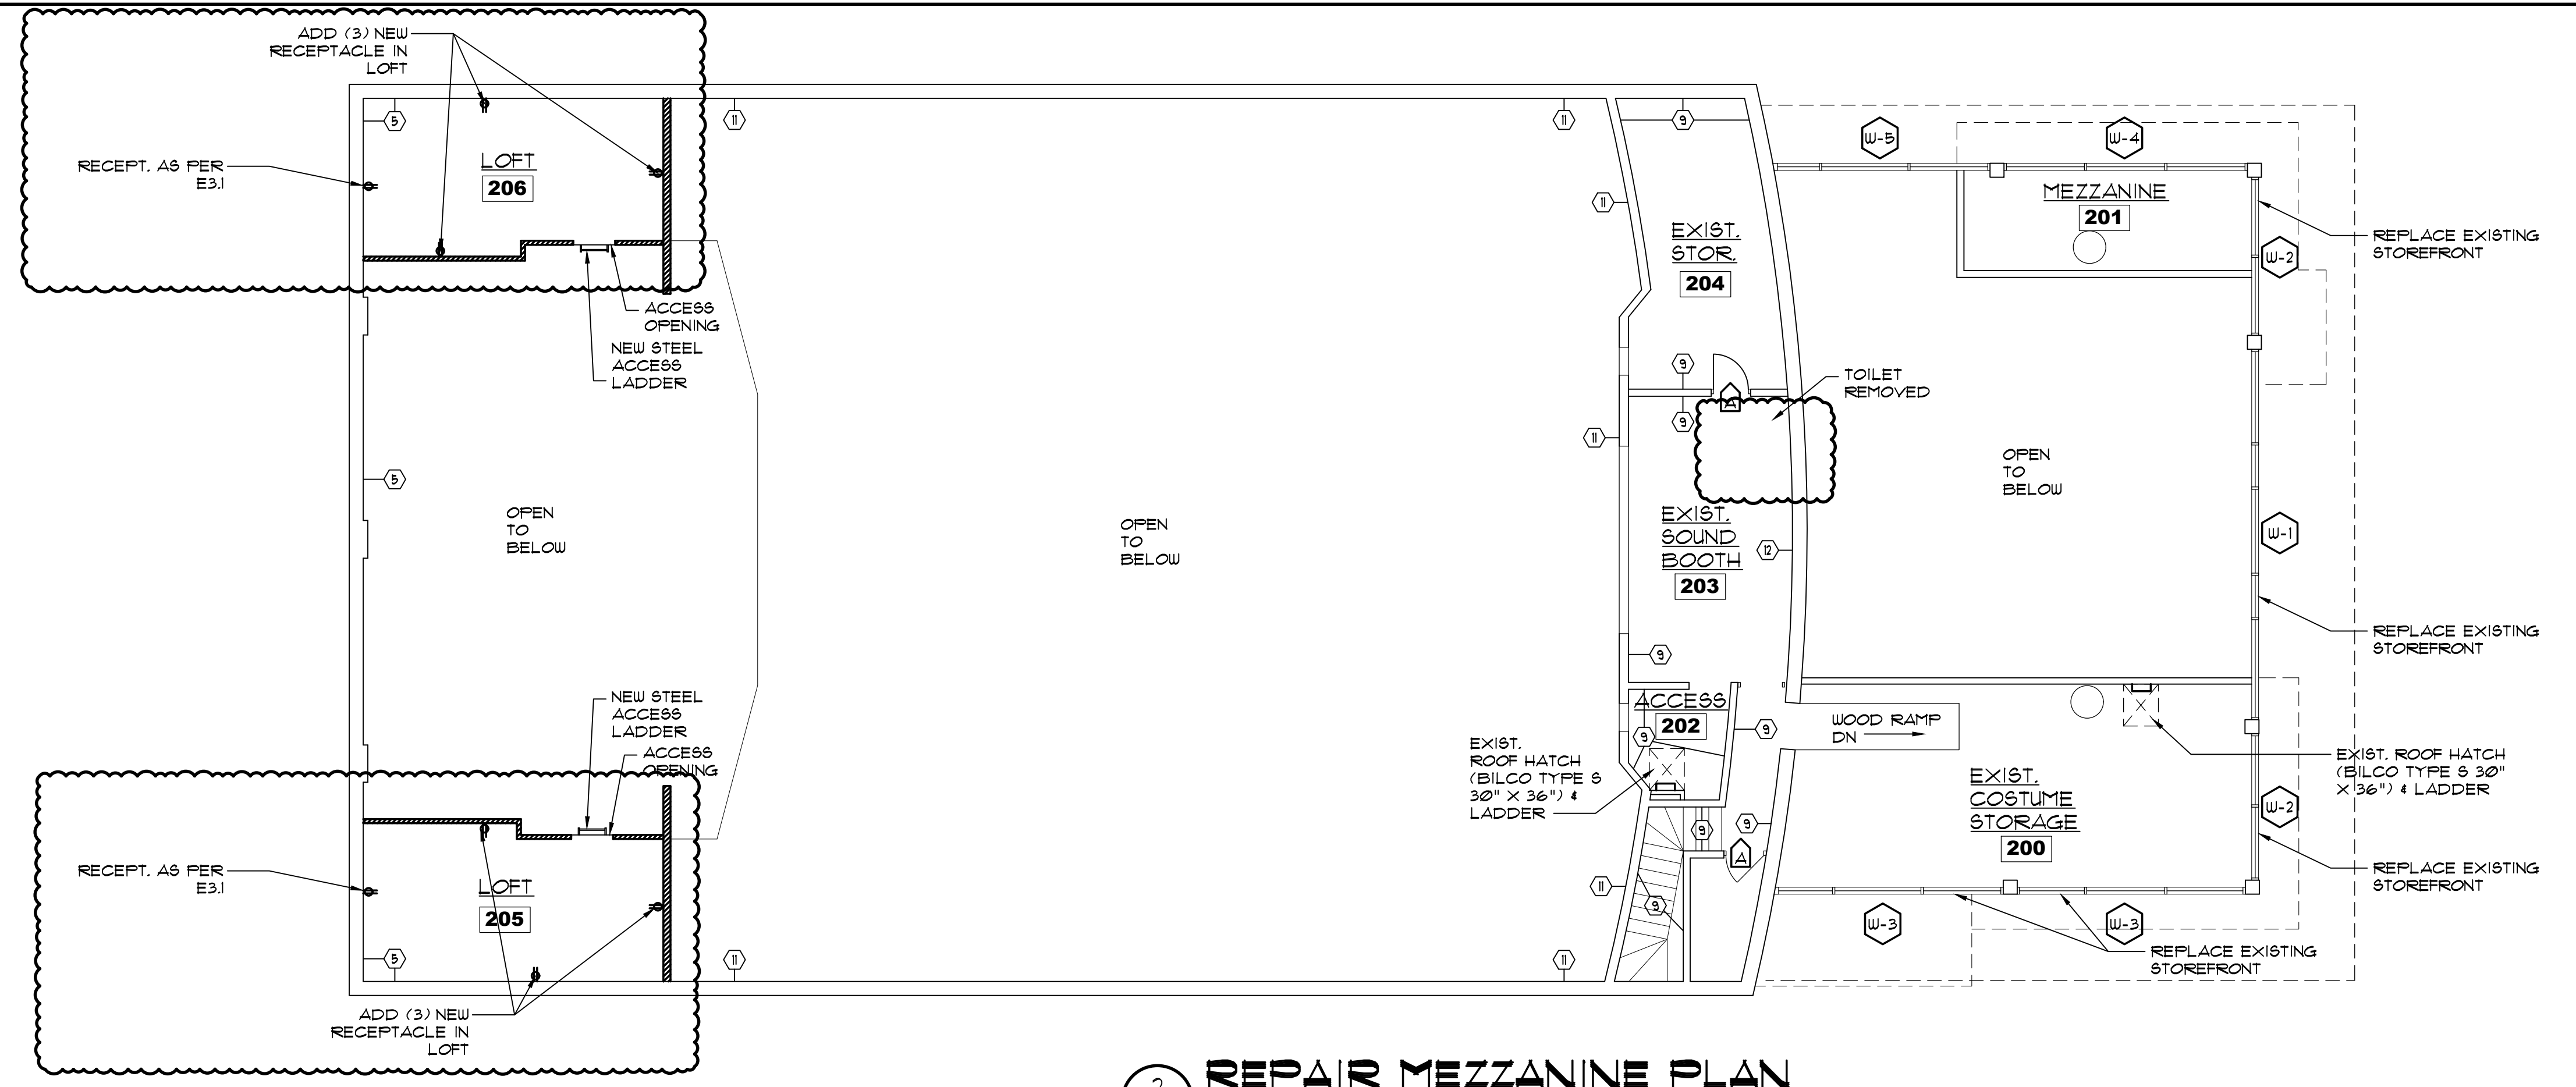
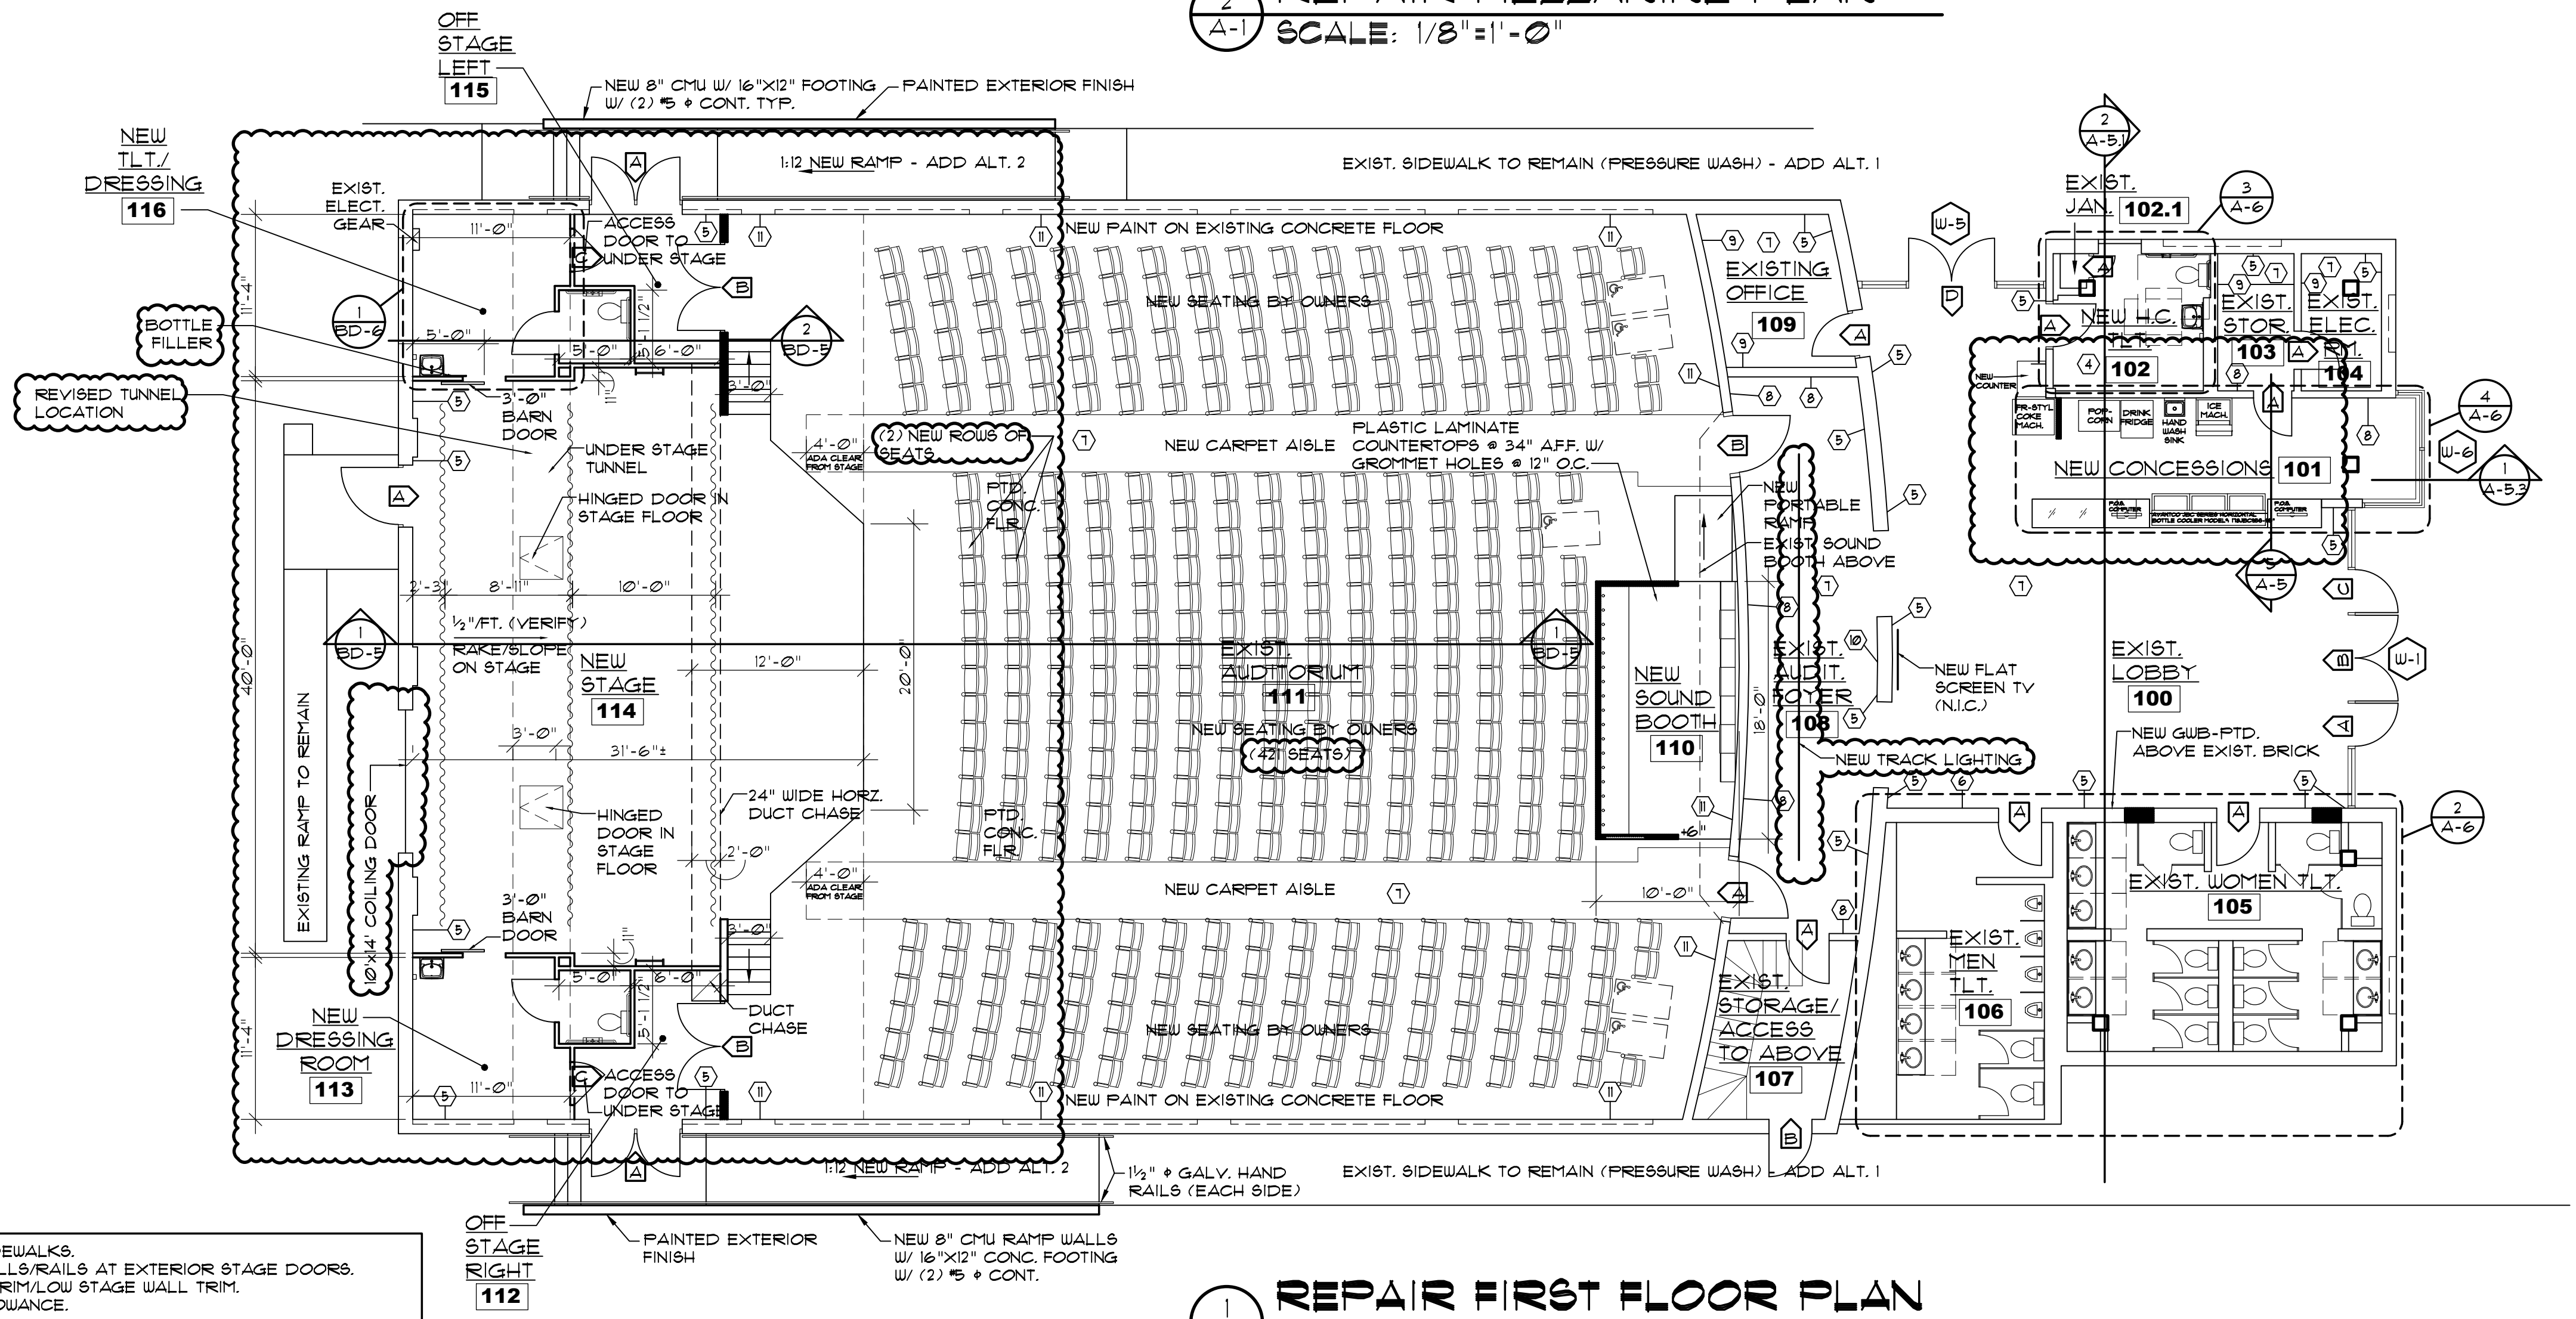
- ① NEW TILE TO MATCH EXISTING ON EXISTING WALL.
- ② NEW TILE ON BACKER BOARD ON EXISTING STUDS.
- ③ EXISTING WALL TILE TO REMAIN.
- ④ EXISTING FLOOR TILE TO REMAIN.
- ⑤ EXISTING EXPOSED BRICK TO REMAIN.
- ⑥ NEW GUB-PTD. ON EXISTING STUDS.
- ⑦ PREP FOR NEW FLOORING - SEE ROOM FINISH SCHEDULE.
- ⑧ NEW 3/8" GUB-PTD. ON EXISTING WALL.
- ⑨ EXISTING MASONRY TO BE PAINTED.
- ⑩ FILL EXISTING HOLE W/ BRICK.
- ⑪ EXISTING MASONRY TO REMAIN (CURTAINS BY OWNER).
- ⑫ EXISTING BRICK - REPAINT BLACK.
